M25XPB Heat exchanger Leak

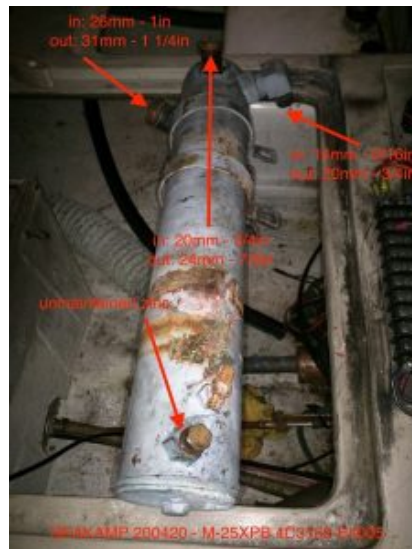
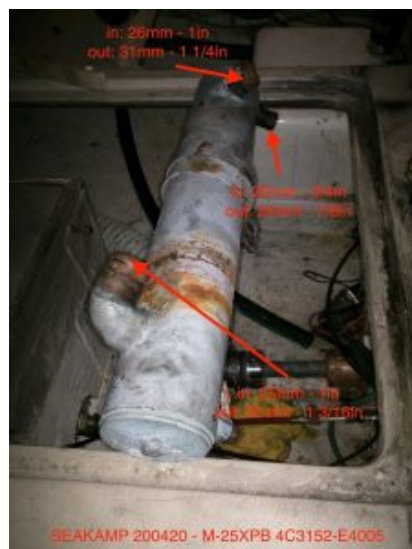
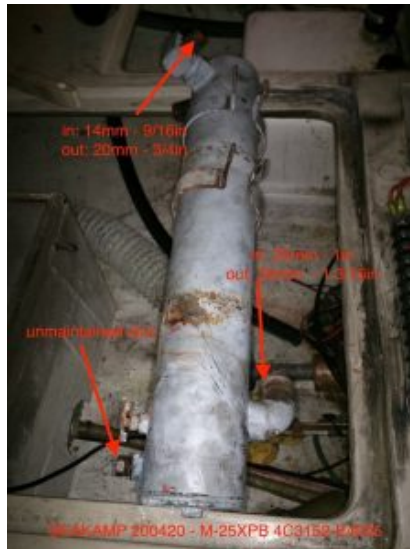
Once removed I was able to read the part number / SKU: Seakamp 200420 and take some measurements.

seakamp 200420
m25xpb heat
exchanger 1

seakamp 200420
m25xpb heat
exchanger 2

seakamp 200420
m25xpb heat
exchanger 3

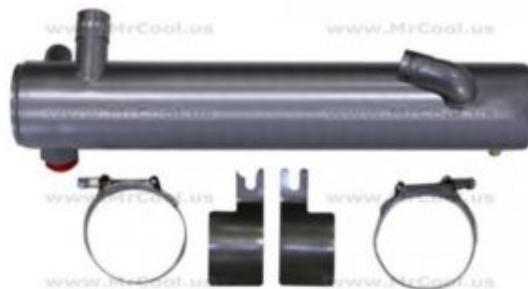
universal-medalist-200420cn

The heat exchanger came with brackets AND clamps as you can see in this picture:

So I felt a bit concerned about the brackets shipped with the HE, if I use them, I don't see how I can use the clamps.

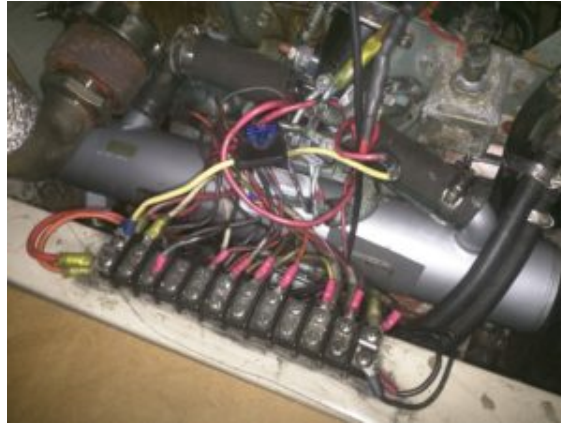
This is how it looked at first:

hotel catalina catalina36
seakamp 200420

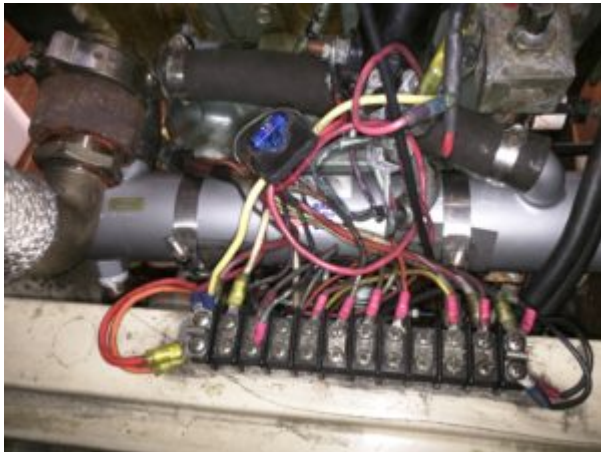
Updated my setup, look a bit more pretty, even if it will be way better when I will move it the way Matthew from Catalina 36 forum suggested it!

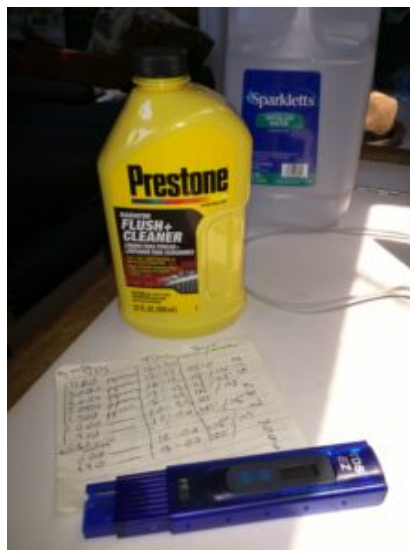
Here a picture of the radiator flush cleaner I used!

Prestone radiator flush cleaner

I also did few (ok a lot of them) flush of my radiator since it seems a lot of salted water has been living on the fresh water side of the cooling system.
