Transmission stiff shifting and control cable replacement

Helm tear down and fixing

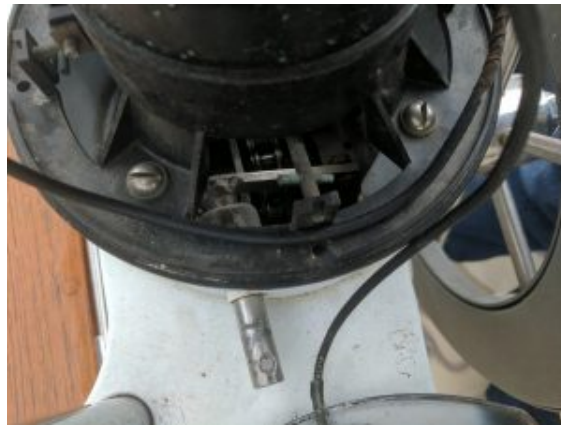
Over the week-end, we had an issue with the transmission where it was not possible to shift to forward gear anymore. Few minutes later and too much play with the gear control, I managed to shear the screw in the shift lever, as you can see in the picture below.

sheared screw in my
catalina 36 shift lever

1. Remove the sheared screw from the lever
 1. How? Still need to figure it out
2. Replace this screw:

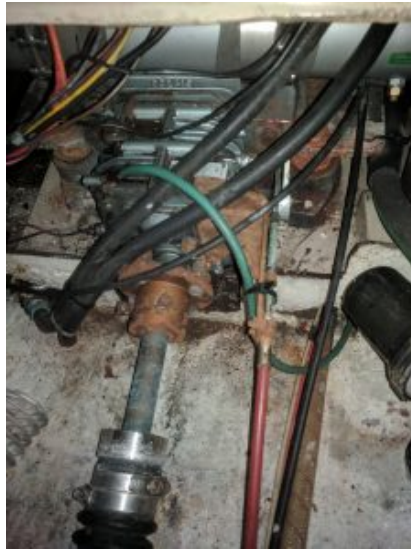
Picture from the
control cable to
replace

1. 14' cable (transmission):
http://www.catalinadirect.com/index.cfm/product/1544_841/engine-control-cable-14br-c-270-c-28-c-310-c-320-c-36.cfm
 2. 15' cable (throttle):
http://www.catalinadirect.com/index.cfm/product/1545_841/engine-control-cable-15brc-34-c-36.cfm

5. Replace the old control cables with a coupling nut (10-32) connecting the old and new one:
 1. <http://www.ebay.com/itm/1JA51-Rod-Coupling-Nut-Grade2-10-32-Pk10-/381002901460>

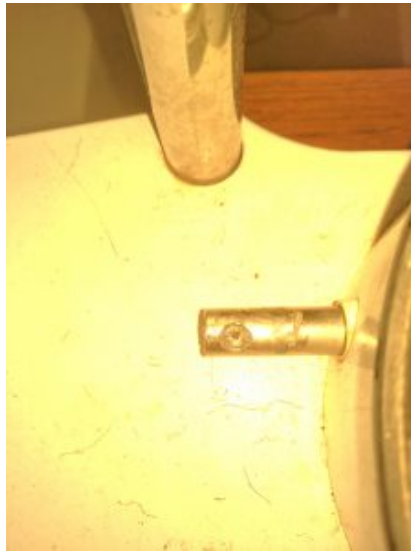
Easier than expected! I was able to get it out pretty easily with an easy out screw extractor after I drilled a small hole in it with a 1/16" cobalt drill bit.

1/16" cobalt drill
bit hole

- 1/4-28 x 3/4" SS screw going to the stainless clutch handle
- <https://www.amazon.com/Button-Socket-Screws-Stainless-Quantity/dp/B00YSS9ZAG/>

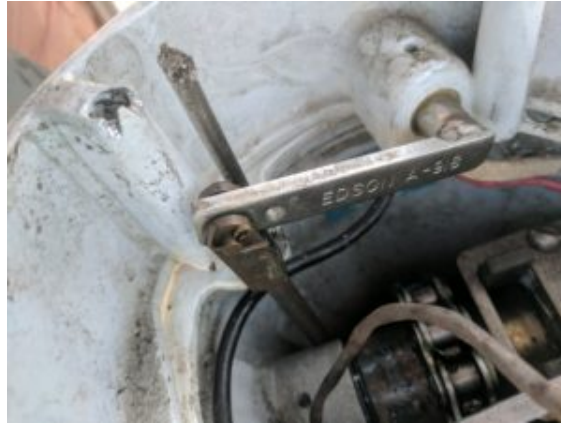
The 3 first ~~1/4"-20 x 3 1/2"~~ 1/4"-20 x 4" stainless machine screw came out very easily and of course as usual one didn't come at all after a lot of drilling and one drill bit broken I succeeded to get the compass out with only one screw to replace!

compass broken screw

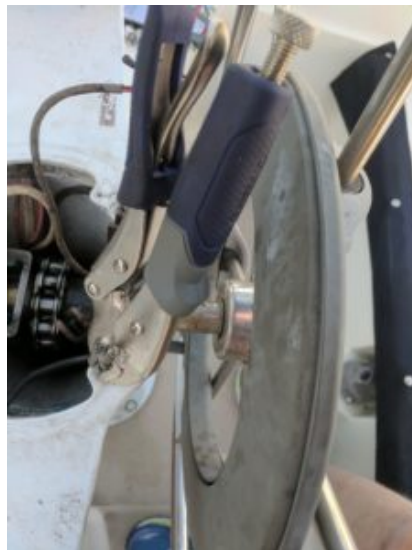
Remove broken ~~$\frac{1}{4}$ "-20 x 3 $\frac{1}{2}$ "~~ $\frac{1}{4}$ "-20 x 4" stainless machine screw

At the beginning based on documentation and online information I ordered by mistake 3 $\frac{1}{2}$ " machine screws where needed 4" long screws.

broken screw
removing method

- $\frac{1}{4}$ "-20 x 4" stainless and should be coated with Tef Gel when installing.
- http://www.edsonmarine.com/marinestore/index.php?main_pa

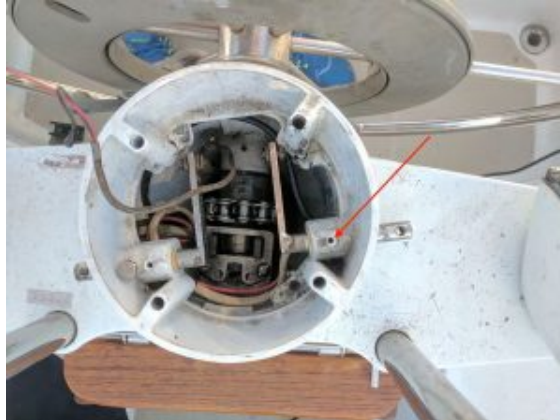
Lost lever assembly to
control housing screw

Those screws are 8-32 pan head machine screws 3/8" long.

I just had to send a quick email to edson to be able to order the needed screw on boltdepot.com.

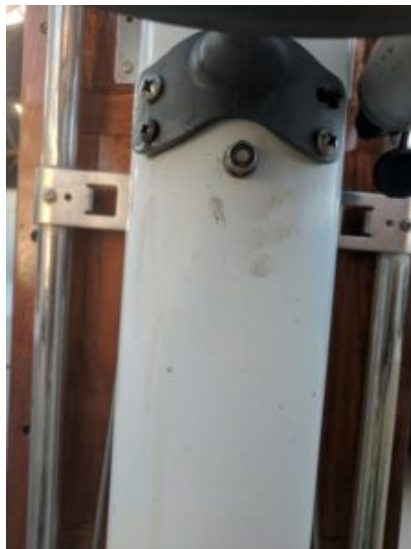
I was doubtful about this part since it looks tedious to get it back there. But it was not as bad as it looked.

screw holding the
cable holder

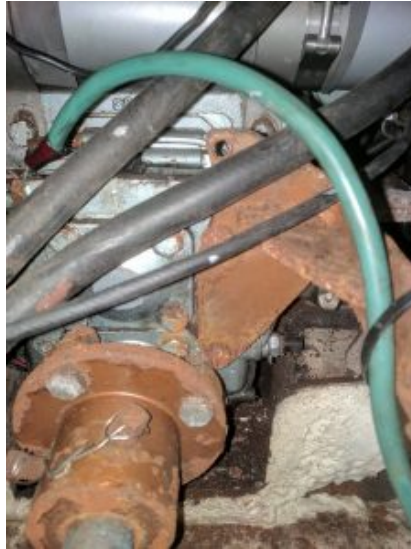
Transmission control
cable holder

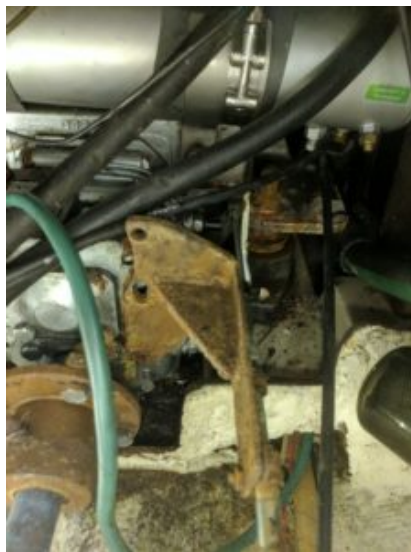
Pretty rusty but not
too difficult to
remove.

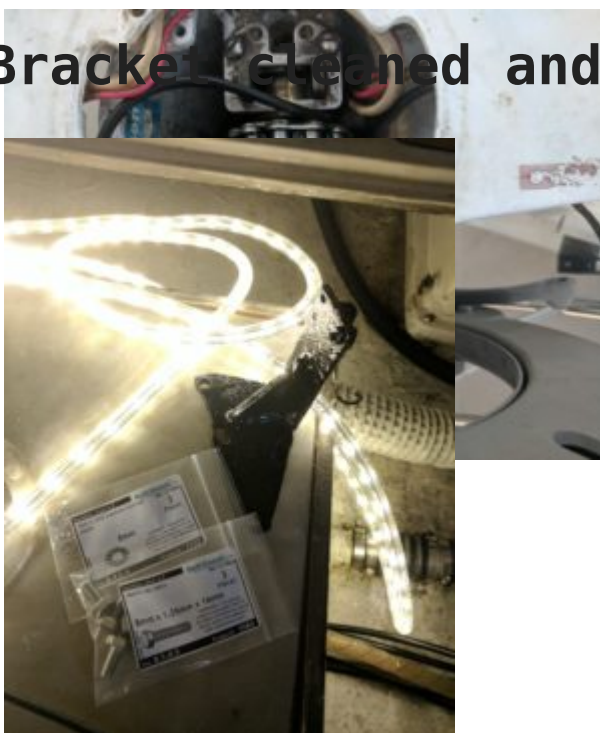
Bracket cleaned and painted

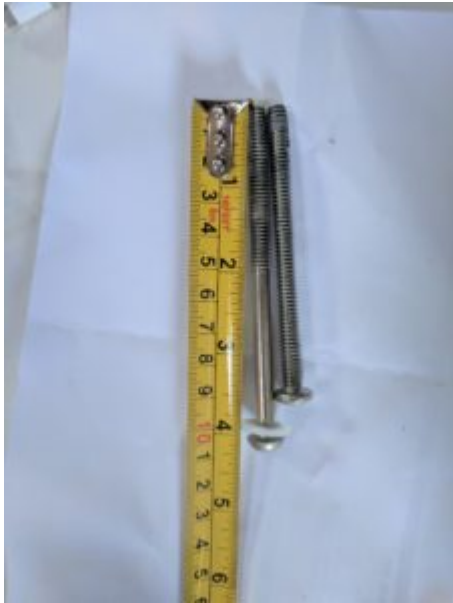
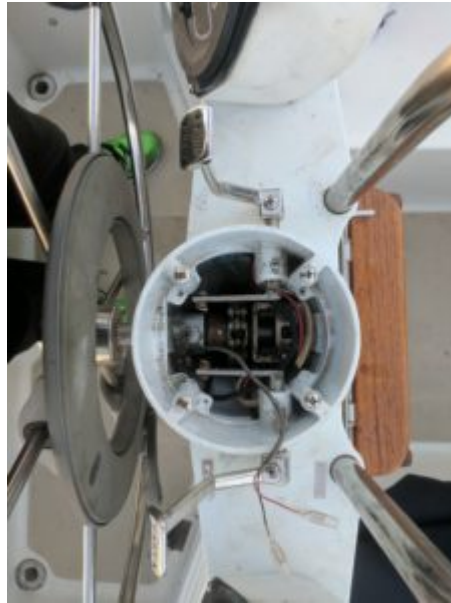
Machines Screw too small for the housing!

First I went back with the old one before to replace them later on.
